Manhole Inspection Summary

Manhole # S65Q__011MH

Insp Date: **4/23/08 9:31 AM**

Location Address: **1500 Cardiff Ave.**

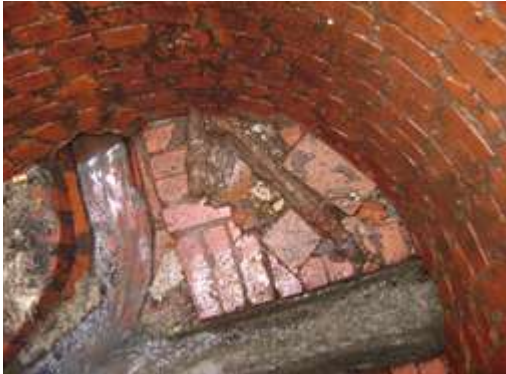
Defect 3

Condition: ☐ Sound ☐ Cracked ☐ Root Intrusion ☐ Deteriorated ☐ Leaks ☒ **Debris**

debris on bench

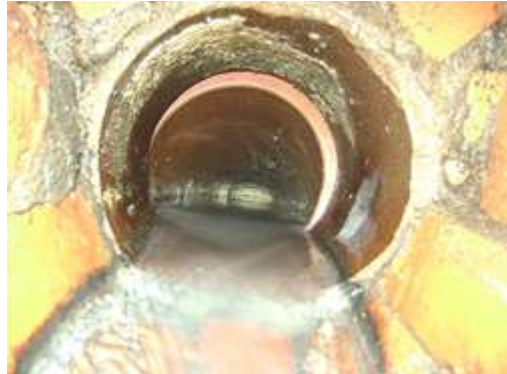
Defect 4

displaced joint (offset) incoming 3 o'clock

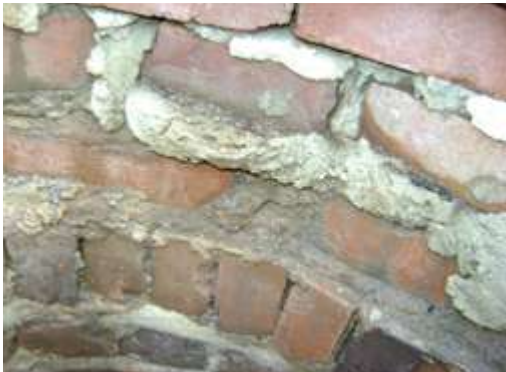
Defect 1

Condition: ☐ Sound ☐ Cracked ☐ Root Intrusion ☒ **Loose Brick** ☒ **Deteriorated**

loose mortar in chimney

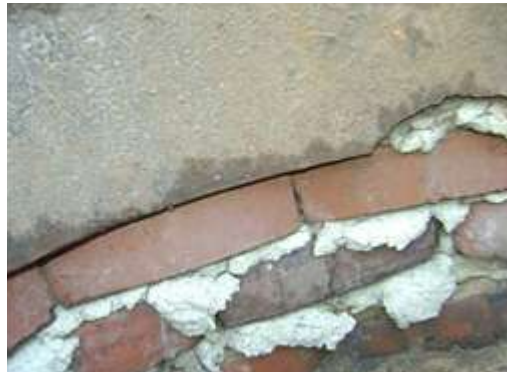
Defect 2

infiltration below frame

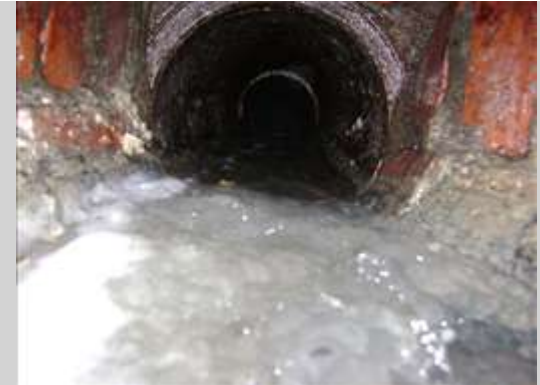
12 O'Clock Outflow

Pipe Height: **8.4** (in.) Rod and Bar (Angled)
Pipe Material: **Clay** ☐ Pipe Lined
Invert Depth: **15.42** (ft.) Flow Characteristics: **Fast**
Deposits: ☒ None ☐ Mud ☐ Sludge ☐ Debris ☐ Grease
Silt Depth: (in.) Deposits Extent:
Infiltration: **None** Pipe Seal Cond: **Sound**

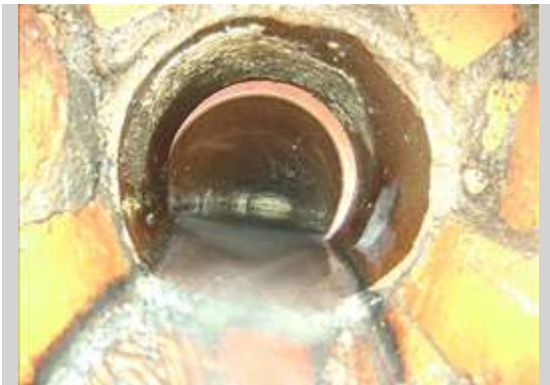
3 O'Clock Inflow

Pipe Height: **8.4** (in.) Rod and Bar (Angled)
Pipe Material: **Clay** ☐ Pipe Lined
Invert Depth: **15.17** (ft.) Flow Characteristics: **Fast**
Deposits: ☒ None ☐ Mud ☐ Sludge ☐ Debris ☐ Grease
Silt Depth: (in.) Deposits Extent:
Infiltration: **None** Pipe Seal Cond: **Sound**

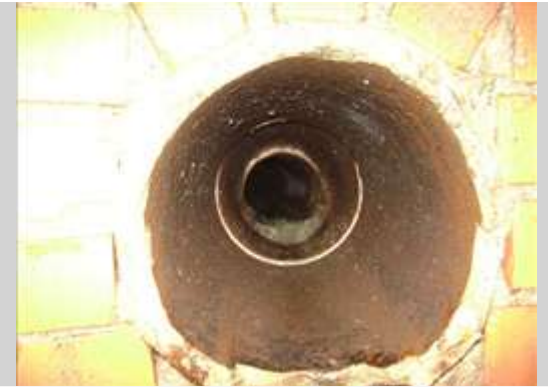
6 O'Clock Inflow

Pipe Height: **8.4** (in.) Rod and Bar (Angled)

Infiltration: **None** Pipe Seal Cond: **Sound**

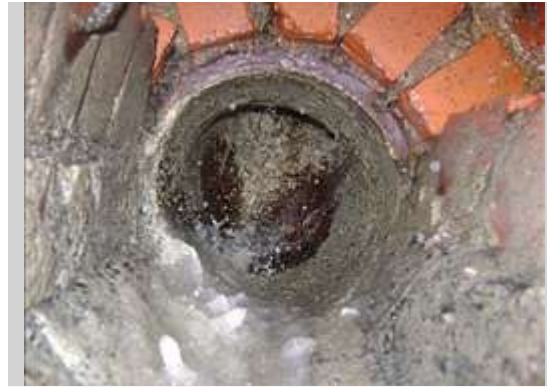
Drop In @ 6 O'Clock

Drop: **Inside**

Drop Condition: **Open**
